# British Mark IV Tank

David Fletcher • Illustrated by Tony Bryan

### BRITISH MARK IV TANK

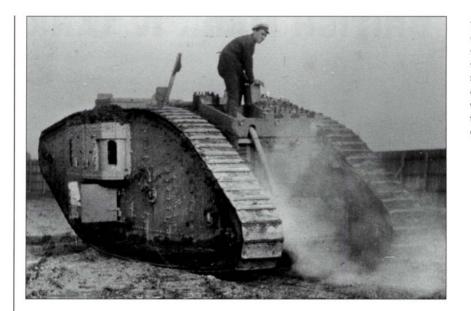
The tank testing ground at Oldbury, near Birmingham, with a brand new Mark IV female ticking over. The Royal Naval Air Service petty officer stowing fuel cans belongs to 20 Squadron, which remained responsible for tank testing until the end of the war.

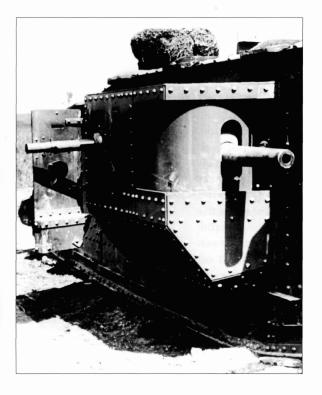
A male sponson, starboard side. The short six-pounder gun in its rotating shield casts a shadow on the lower, more angular plates. Farther back is a Lewis gun in the ball mounting, looking massive. Notice that, in contrast to the Mark I, the door on a Mark IV male sponson swings outwards.

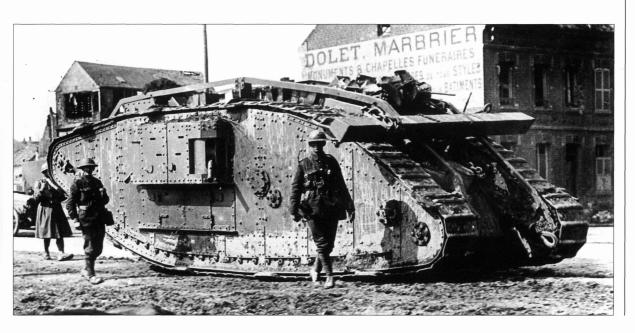
A famous picture taken in Peronne selected to show the stowed unditching beam, the vast number of spare petrol cans carried on the roof and the end of a towing cable at the back. It is also worth remarking how often tanks are seen with no obvious markings on display at all.

was soon eclipsed by a far more effective device known as the unditching beam. It is believed to have been devised by Philip Johnson, then serving as an engineer officer at Erin. The beam itself was a solid piece of oak, protected by steel plates on two sides, which could be chained to the tracks and dragged around underneath the tank if it became ditched, in order to provide a firm purchase. Since the beam weighed in the region of 508kg (1,118lb) it was not easy to manhandle, so each tank was provided with a set of rails running from front to back along the top of the tank and high enough to clear the cab and other fittings. When not required the beam was carried on top of the tank and secured to these rails. Once the tank was stuck two crew members, each with pockets full of spanners, would climb onto the tank and attach the beam to the tracks by means of a sort of chain-and-stirrup arrangement. The driver would then put the tank in gear, lock the differential and use the beam to get out of the hole. On very bad ground some drivers kept going with the beam attached until they were safely onto firmer ground. Then the tank stopped, with the beam back on its rails, to be stowed for the next time. Bearing in mind that this was often done under fire, and sometimes more than once in a single action, the role of the volunteers who attached it is not to be envied. As a corollary to this it should be noted that once the unditching gear design was worked out a requirement was issued for the equipment to be manufactured in Britain. Since nobody would take on the job, pleading pressure of other work, Central Workshops in France made all the unditching gear for the Mark IV tanks, so it is reasonably safe to say that any Mark IV tank seen with the rails fitted had experienced service in France at one time or another.

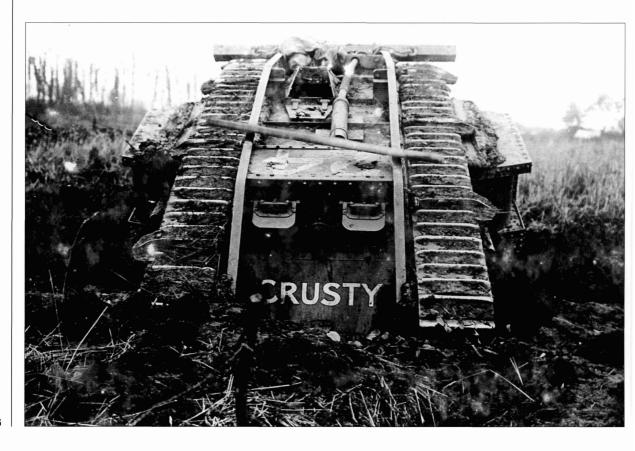
The 3rd Battalion tank *Crusty* provides us with a good view of the top. The bar above the cab seems to have broken loose from somewhere, but it is possible to see the number 24 (painted on top of the cab), the covers for the periscope holes, the silencer and roof hatch, which is open. Notice also the rear stowage position of the unditching beam and the mud that accumulates on top of the sponsons.

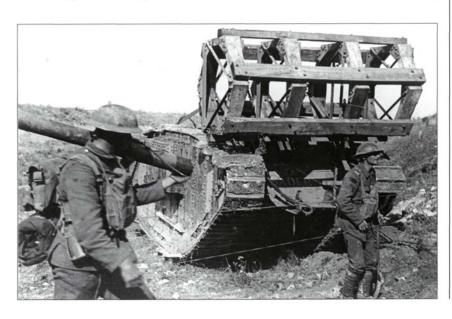
The crib, essentially a lighter, reusable fascine, was rarely seen on Mark IV tanks, but this female with a broken track is carrying one during the attack on the Hindenburg Line on 27 September 1918 in support of the Canadians.

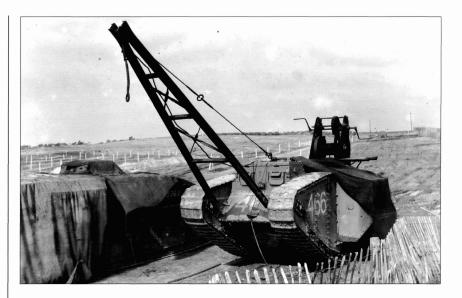
Number 466 was the unusual combination of a training tank with supply sponsons. It was used at Bovington as a crane tank with a standard jib. The big winch at the back operates the hoist instead of the usual chain system.

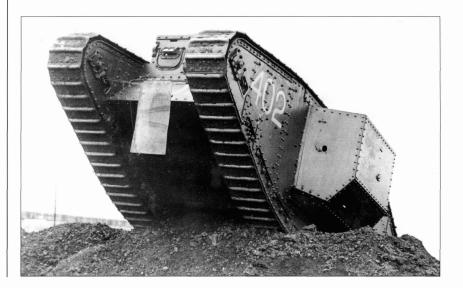
This is the Mark IV supply tank used for aircraft-to-tank wireless communication trials at Biggin Hill towards the end of the war. The panel suspended by string between the front horns is presumably something to do with the receiving process.

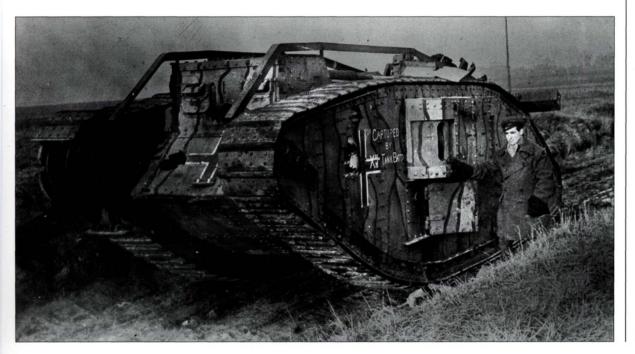
This unusual photograph shows a Mark IV female Beutepanzer that may have been a victim of the fighting on 8 October 1918. The legend on the side claims that it was captured by 12th Battalion and the damage to the side and front, not to mention the broken track, suggests that it has been in a fight. If so it would be one of the German 15th Battalion tanks that participated in the second tank-versus-tank action of the war.

The last battle involving Mark IV tanks seems to have been towards the end of Second Cambrai on 8 October, when 12th Battalion had the unusual experience of confronting four Mark IV tanks in German hands near Niergnies. Accounts of the action are confusing and contradictory, but it may be that male tank L16 put one of the *Beutepanzers* out of action. The German tanks, or their supporting artillery, exacted some revenge and knocked out at least three of the British Mark IVs, including L16, while the crew of L8 used a captured German gun to smash another of the German tanks. When another Mark IV, albeit a female, rolled up from the British side, the remaining German tanks departed.

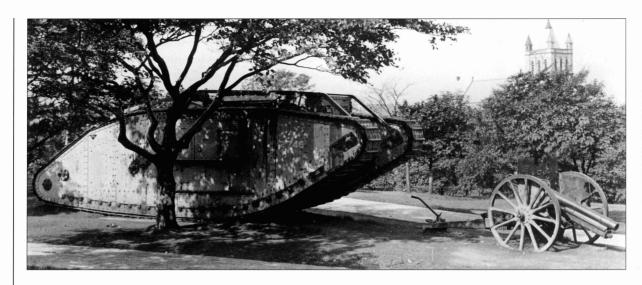
The Mark IV female presented to Barnsley, and displayed in Locke Park, is a genuine veteran; the unditching beam rails and red and white stripes are a giveaway. Though no proof has been found as yet, some evidence suggests that captured enemy artillery was donated to towns with Victoria Cross recipients, so the German 77mm gun in front of the tank might indicate this.

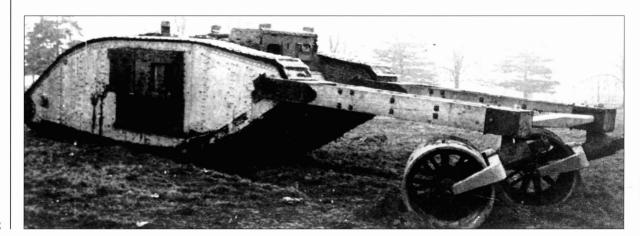
This is the only known photo of the Mark IV anti-mine roller, which is believed to have been completed at Christchurch at the end of the war. The rolls are clearly taken from a couple of steamrollers and are pivoted like castors. Why the tank is painted as it is, in contrast to the sponson, is not clear.

heavy roller device and a Mark IV female was used for one such experiment at Christchurch. Two hefty wooden beams extended forwards from the track horns. At the end of each was a complete front roller drum from a commercial steam road roller. It must have been very hard work for the tank, but the vehicle was completed too late to make any difference.

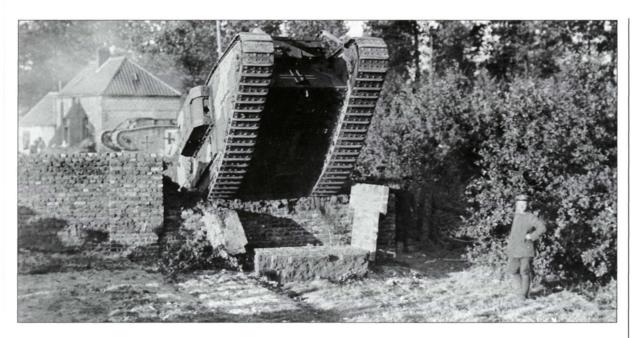
German crews train on captured Mark IV tanks at St Amand in Belgium. The Germans made far more use of interesting camouflage patterns than did the Tank Corps but then, for practical purposes, were obliged to adorn their tanks with large black crosses.
